## **17 Architectural Built Heritage**

## **17.1 Introduction**

This Chapter assesses the impact of the proposed development on the Architectural Heritage of the site and of the surrounding Architectural Heritage, specifically Protected Structures, Architectural Conservation Areas and candidate Architectural Conservation Areas.

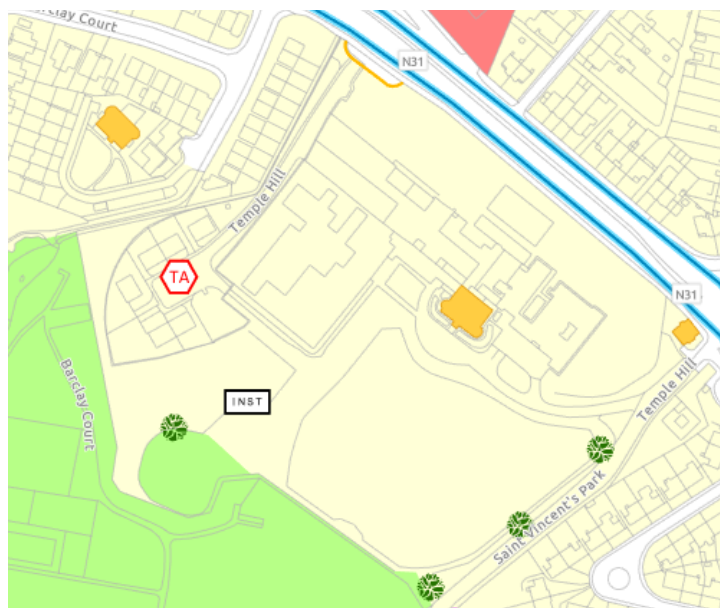
Figure 17.2 - Dun Laoghaire Rathdown Development Plan Protected Structures coloured Orange  
A: House (centre); B: Lodge (right); C: Gateway (top)

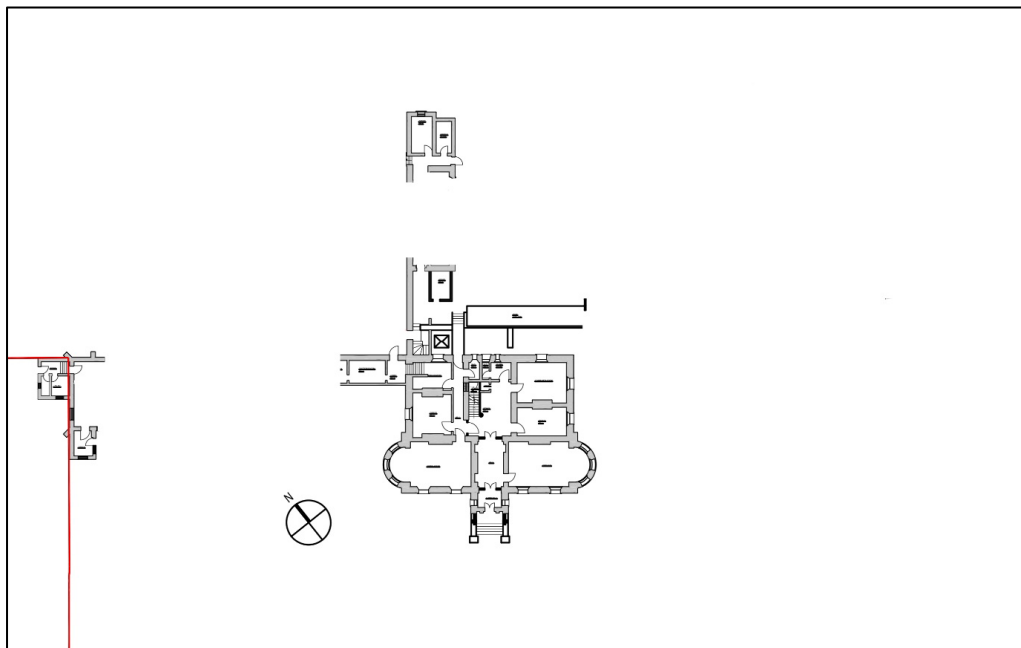
Figure 17.3a - Key Plan January 2026

Note: All buildings adjoining St Teresa's House (centre), above, have now been demolished or substantially demolished.

The house was known as Craigmore at the time of its construction in 1862 and was acquired by the Daughters of Charity in 1925 who renamed it St Teresa's or St Therese. The contemporaneous house to the southeast was known as Dunardagh and was renamed St Catherine's and is also owned by the Daughters of Charity. The names are used below depending on the period referred to. The house was built as a private home for William Hogg and not, it seems, his son Jonathan as is sometimes recorded<sup>2</sup>. The house continued in the Hogg family ownership until 1925. Since then, the house has been substantially extended to the north-west, northeast and southeast. **These extensions have been demolished or substantially demolished during 2021. See Figure 17.3a below.**

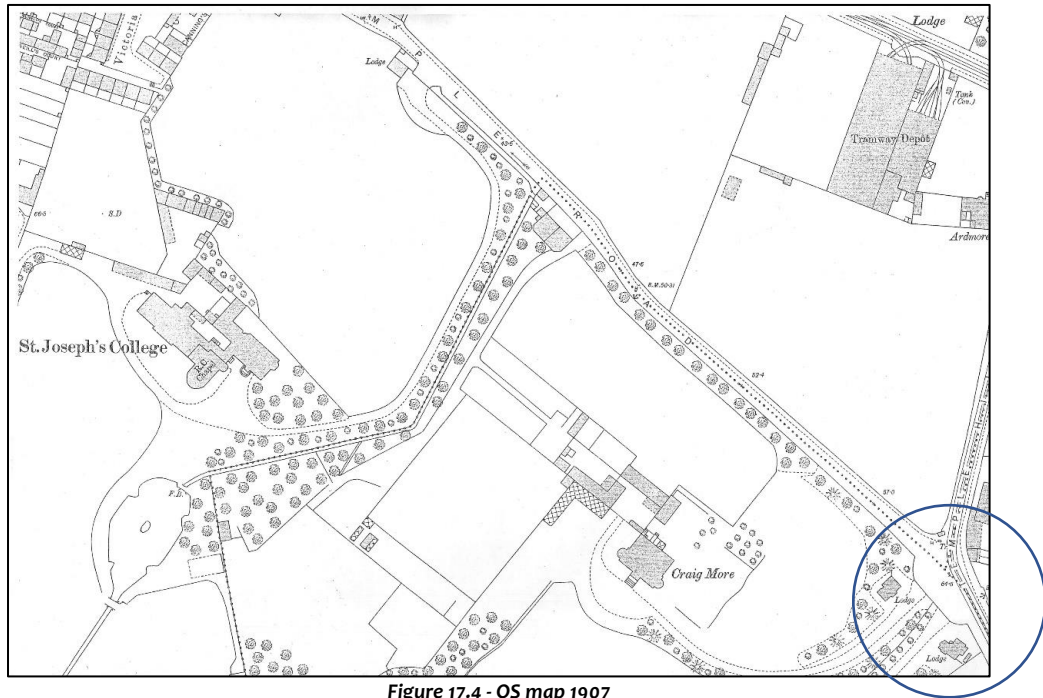
Figure 17.4 - OS map 1907  
Note: gates and double avenue at eastern corner

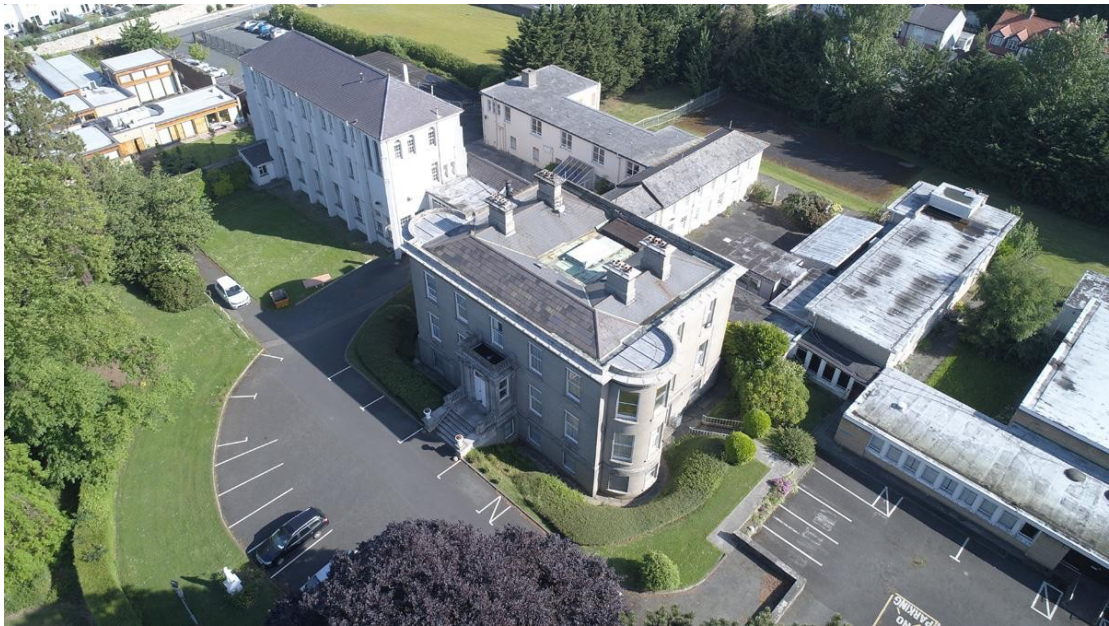
*Figure 17.6 - Aerial view from South (pre-2021 demolitions)*

St. Teresa’s House is a two storey over basement detached country house, of five bays with central projecting granite porch, and semi-circular end-bays, and granite cornice, cills, and string course. The porch is reached via a flight of granite steps with granite flank walls. There is a pitched “A” roof having its ridge in a “U” shaped plan, with central flat-roofed area and rooflight above the stairs, and with lead roofs with rolls to the end bays with hip valleys valley gutters and parapet gutters rendered chimneys stacks. The external walls are rendered and lined, with one-over-one pane vertical sliding sash sliding windows.

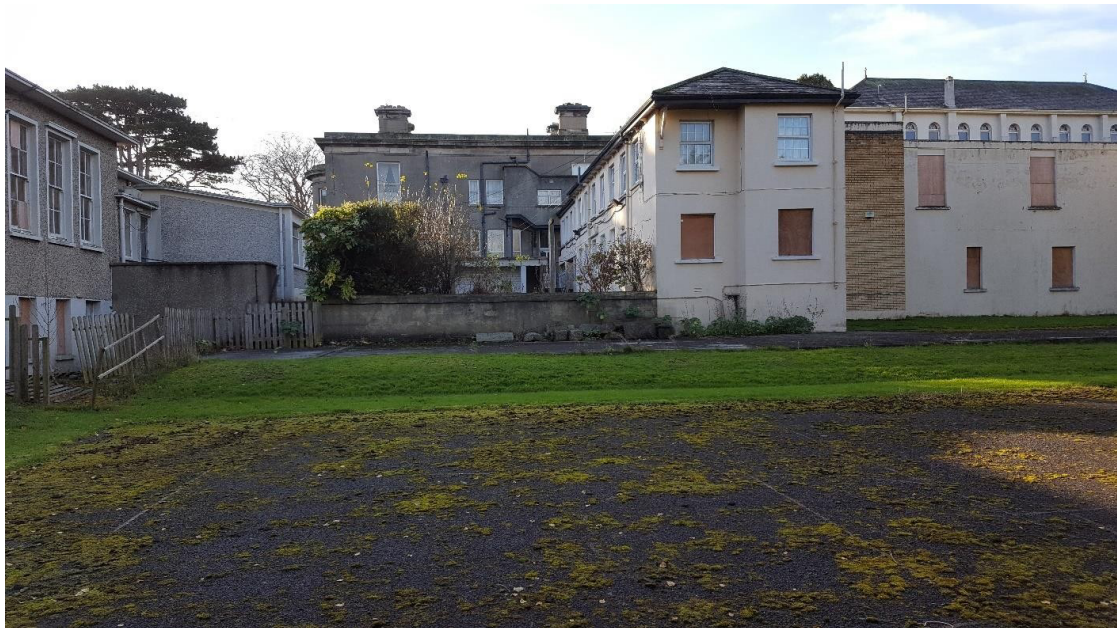
*Figure 17.7 - View from North-east (pre-2021 demolitions)*

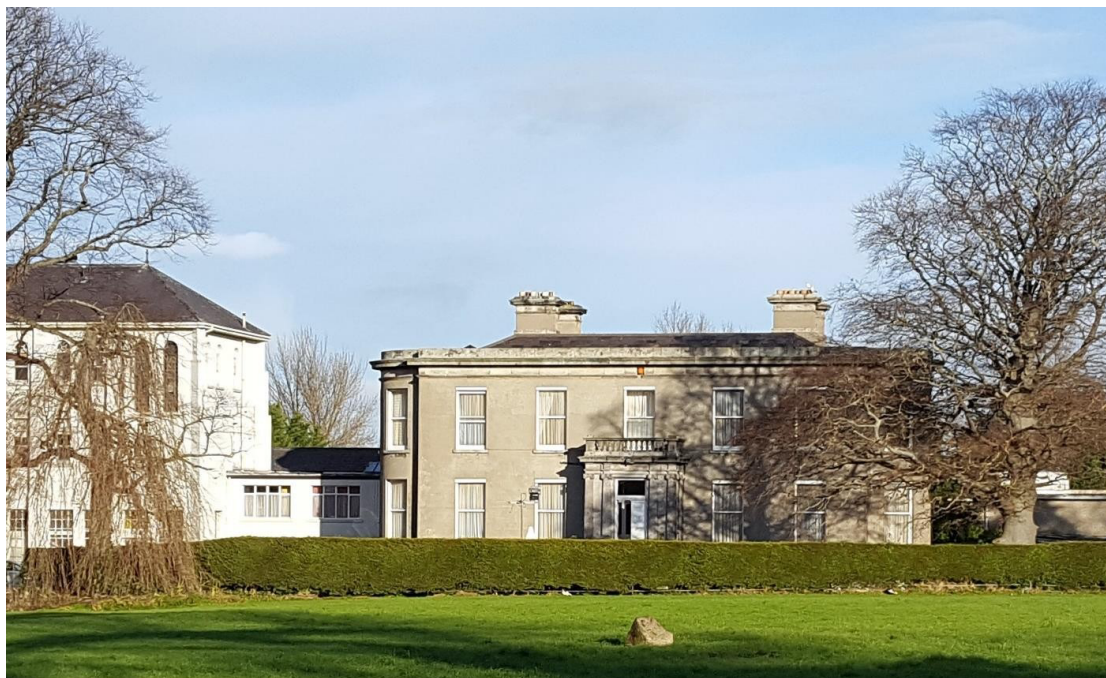
Figure 17.8 - View from South-west (pre-2021 demolitions)

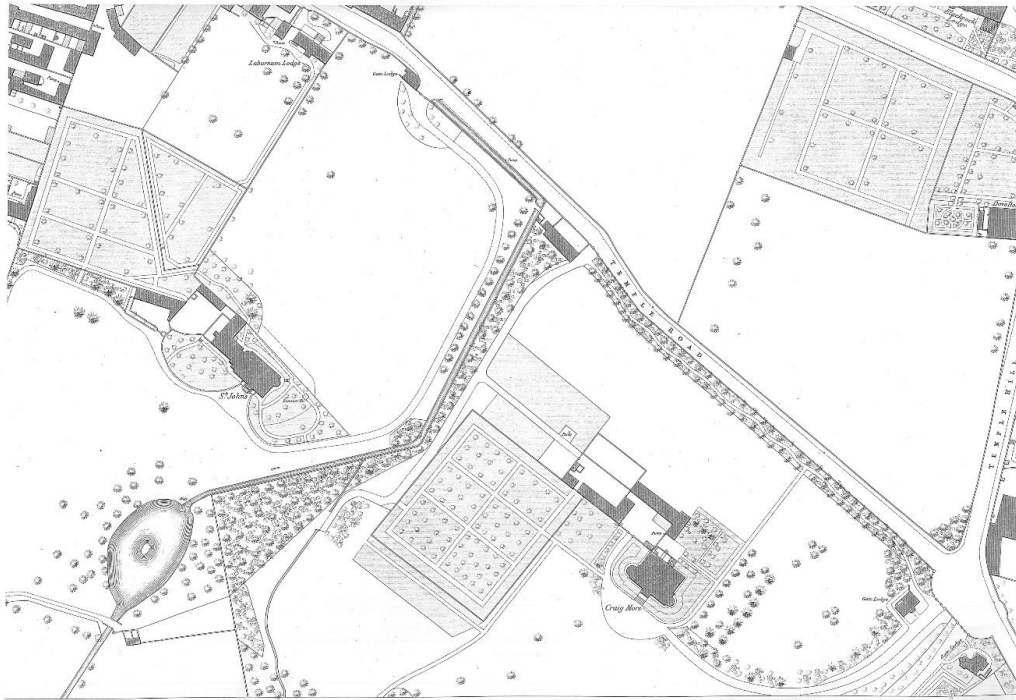
**Figure 17.9 - 1867 OS Map**  
**Note: lodge now shown as having been built since 1865 map**

J.A.K. Dean<sup>5</sup>, describes this lodge as a of a pattern to be found in a number of other locations and suggests that the demolished west lodge was the only approach for more than a decade. However, the 1865 and 1867 maps do not seem to bear this out and it seems unlikely that main entrance was ever at the north corner of the site.<sup>1</sup>

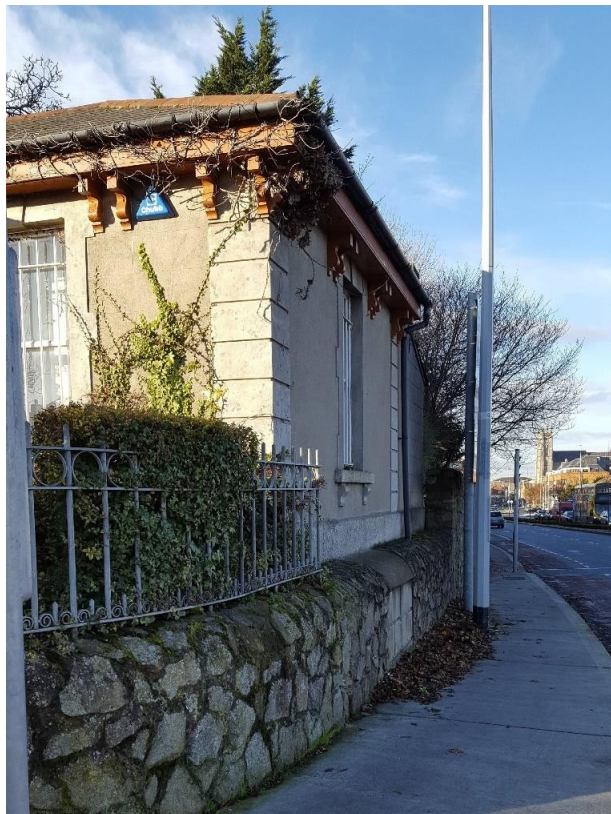
**Figure 17.10 - New boundary wall**

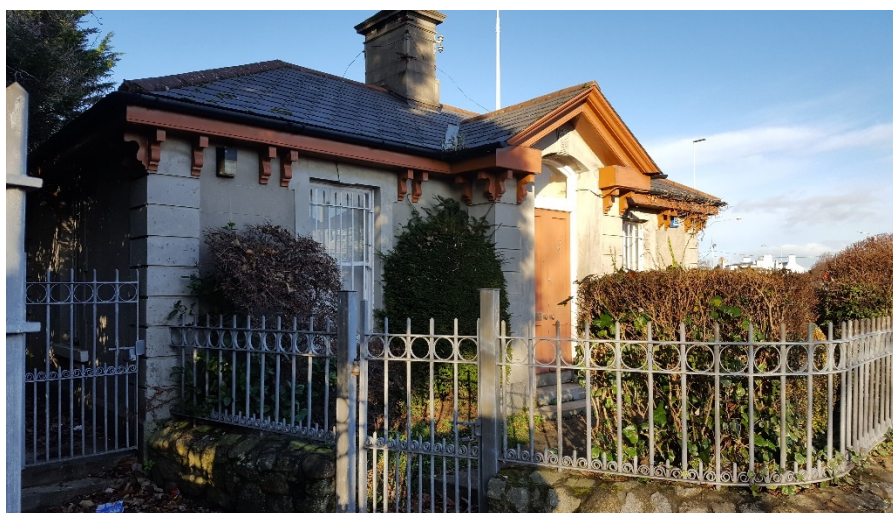
The building is a single storey double-fronted lodge, open pedimented breakfront, one over one windows with granite cills and lugged architraves, granite plinth and rendered quoins. It has a hipped roof with central chimney with granite capping and plinth and double console eaves brackets. A room by room description is attached. J.A.K. Dean<sup>2</sup> describes it as being Italianate in style and of a pattern common in south Dublin, referring to similar examples in Newtownpark, Homestead and Tirbradden.

***Lodge at St Teresa's House***
