17 Architectural Built Heritage

This Chapter assesses the impact of the proposed development on the Architectural Heritage of the site and of the surrounding Architectural Heritage, specifically Protected Structures, Architectural Conservation Areas and candidate Architectural Conservation Areas.

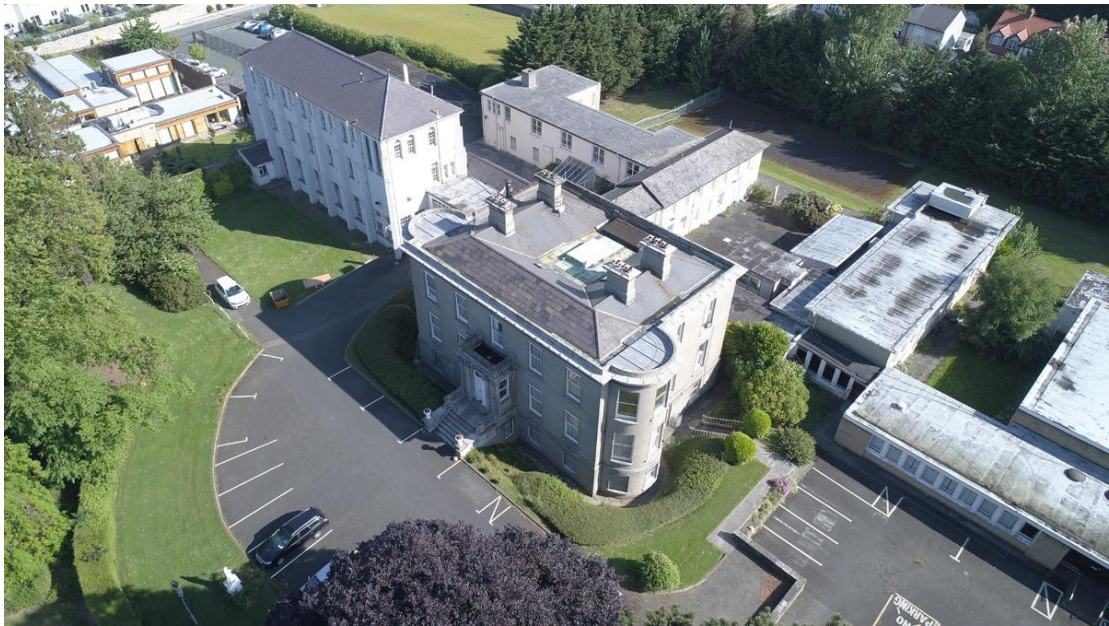
Figure 17.6 - Aerial view from South (pre-2021 demolitions)

St. Teresa’s House is a two storey over basement detached country house, of five bays with central projecting granite porch, and semi-circular end-bays, and granite cornice, cills, and string course. The porch is reached via a flight of granite steps with granite flank walls. There is a pitched “A” roof having its ridge in a “U” shaped plan, with central flat-roofed area and rooflight above the stairs, and with lead roofs with rolls to the end bays with hip valleys valley gutters and parapet gutters rendered chimneys stacks. The external walls are rendered and lined, with one-over-one pane vertical sliding sash sliding windows.

The exterior of the building is in poor condition having many external service pipes, abutting later extensions, and some non-original windows. The render is cracked in places. The interior of the building has been somewhat altered to accommodate the institutional use, but the main features remain relatively intact. A room by room inventory and photographic record is attached.

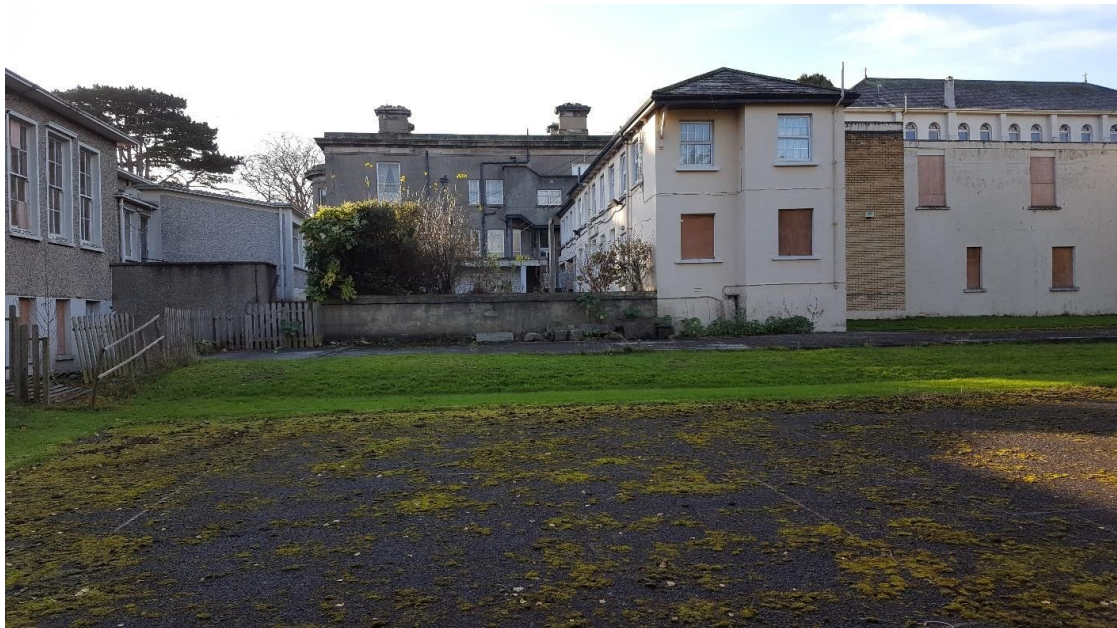
Figure 17.7 - View from North-east (pre-2021 demolitions)

There will be an impact on the setting of the house which especially as viewed from the northeast, will be altered. The proposed single storey (above basement) pavilion it is suggested, will be a perfectly reasonable replacement of the extensive and numerous accretions to the building which have existed, until recently, for up to seventy years and removal will actually enhance the setting of the house as viewed from the rear. The proposed C3 is a lightweight glazed pavilion, providing communal facilities, which will complement the form and massing of the house, while being constructed in a crisp and elegant modern style.

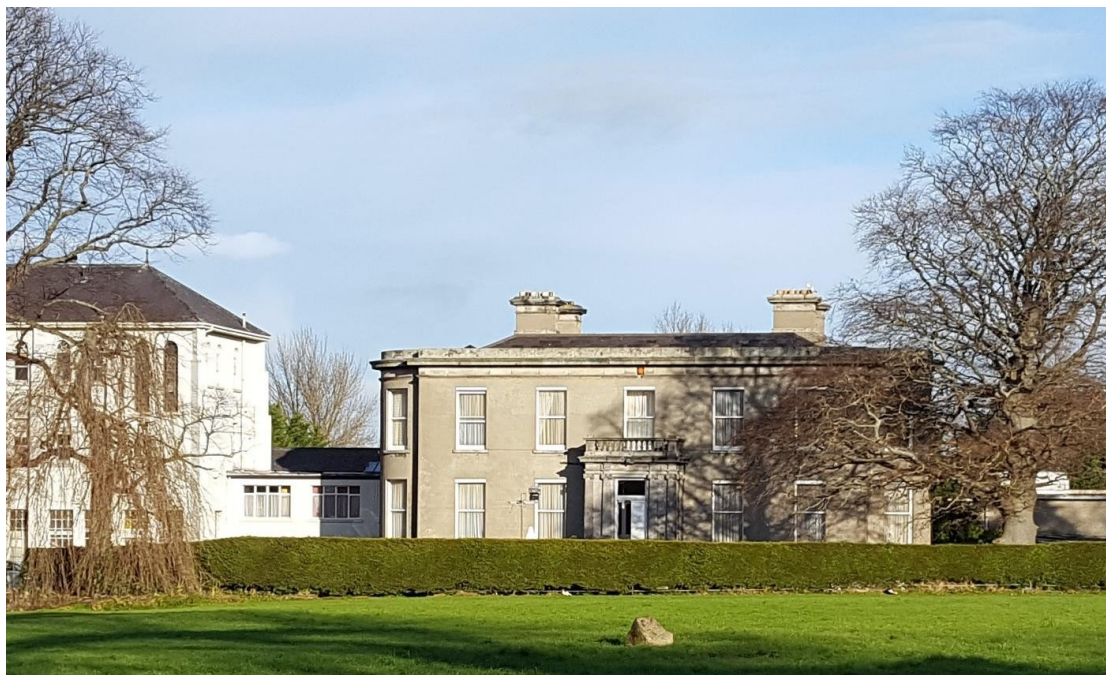
Figure 17.8 - View from South-west (pre-2021 demolitions)

The grounds are distinguished by the curved approach avenue lined with mature trees which create a sylvan setting. The line of the trees is extended across to the southwest side of the house forming its context and defining its immediate curtilage. The grounds have been greatly reduced in quality by the construction of the various extensions over the years, and by the finishing of the traditional forecourt in tarmac and its use and marking as a large car park. The walled garden to the west has been separated from the property and built upon. The grounds to the north and east have been diminished by mediocre institutional buildings. The lands to the south of the house which remain predominantly as a meadow, with a wooded area to the western corner, remain much as they would have been at the time of Craigmores construction.

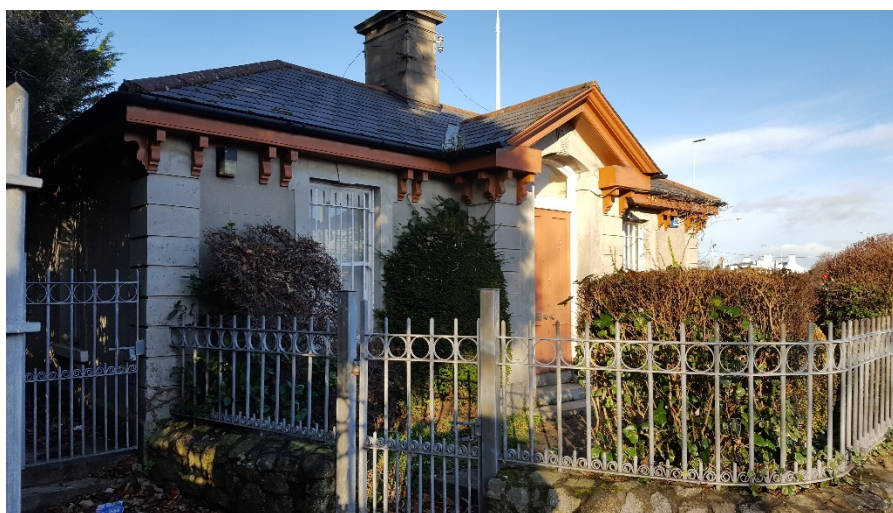
Lodge at St Teresa's House

The building is a single storey double-fronted lodge, open pedimented breakfront, one over one windows with granite cills and lugged architraves, granite plinth and rendered quoins. It has a hipped roof with central chimney with granite capping and plinth and double console eaves brackets. A room by room description is attached. J.A.K. Dean² describes it as being Italianate in style and of a pattern common in south Dublin, referring to similar examples in Newtownpark, Homestead and Tirbradden.
